SOLUTIA - 005

Re: 1631210006 -- St. Clair County
Solutia (Monsanto - W.G. Krummrich Plant)
ILD000802702
Log No. C-777
Received: September 2, 1997
RCRA Closure

**Foundation
Report**

FIGURE 1
SITE LOCATION MAP
W.G. KRUMMRICH PLANT, SAUGET, IL

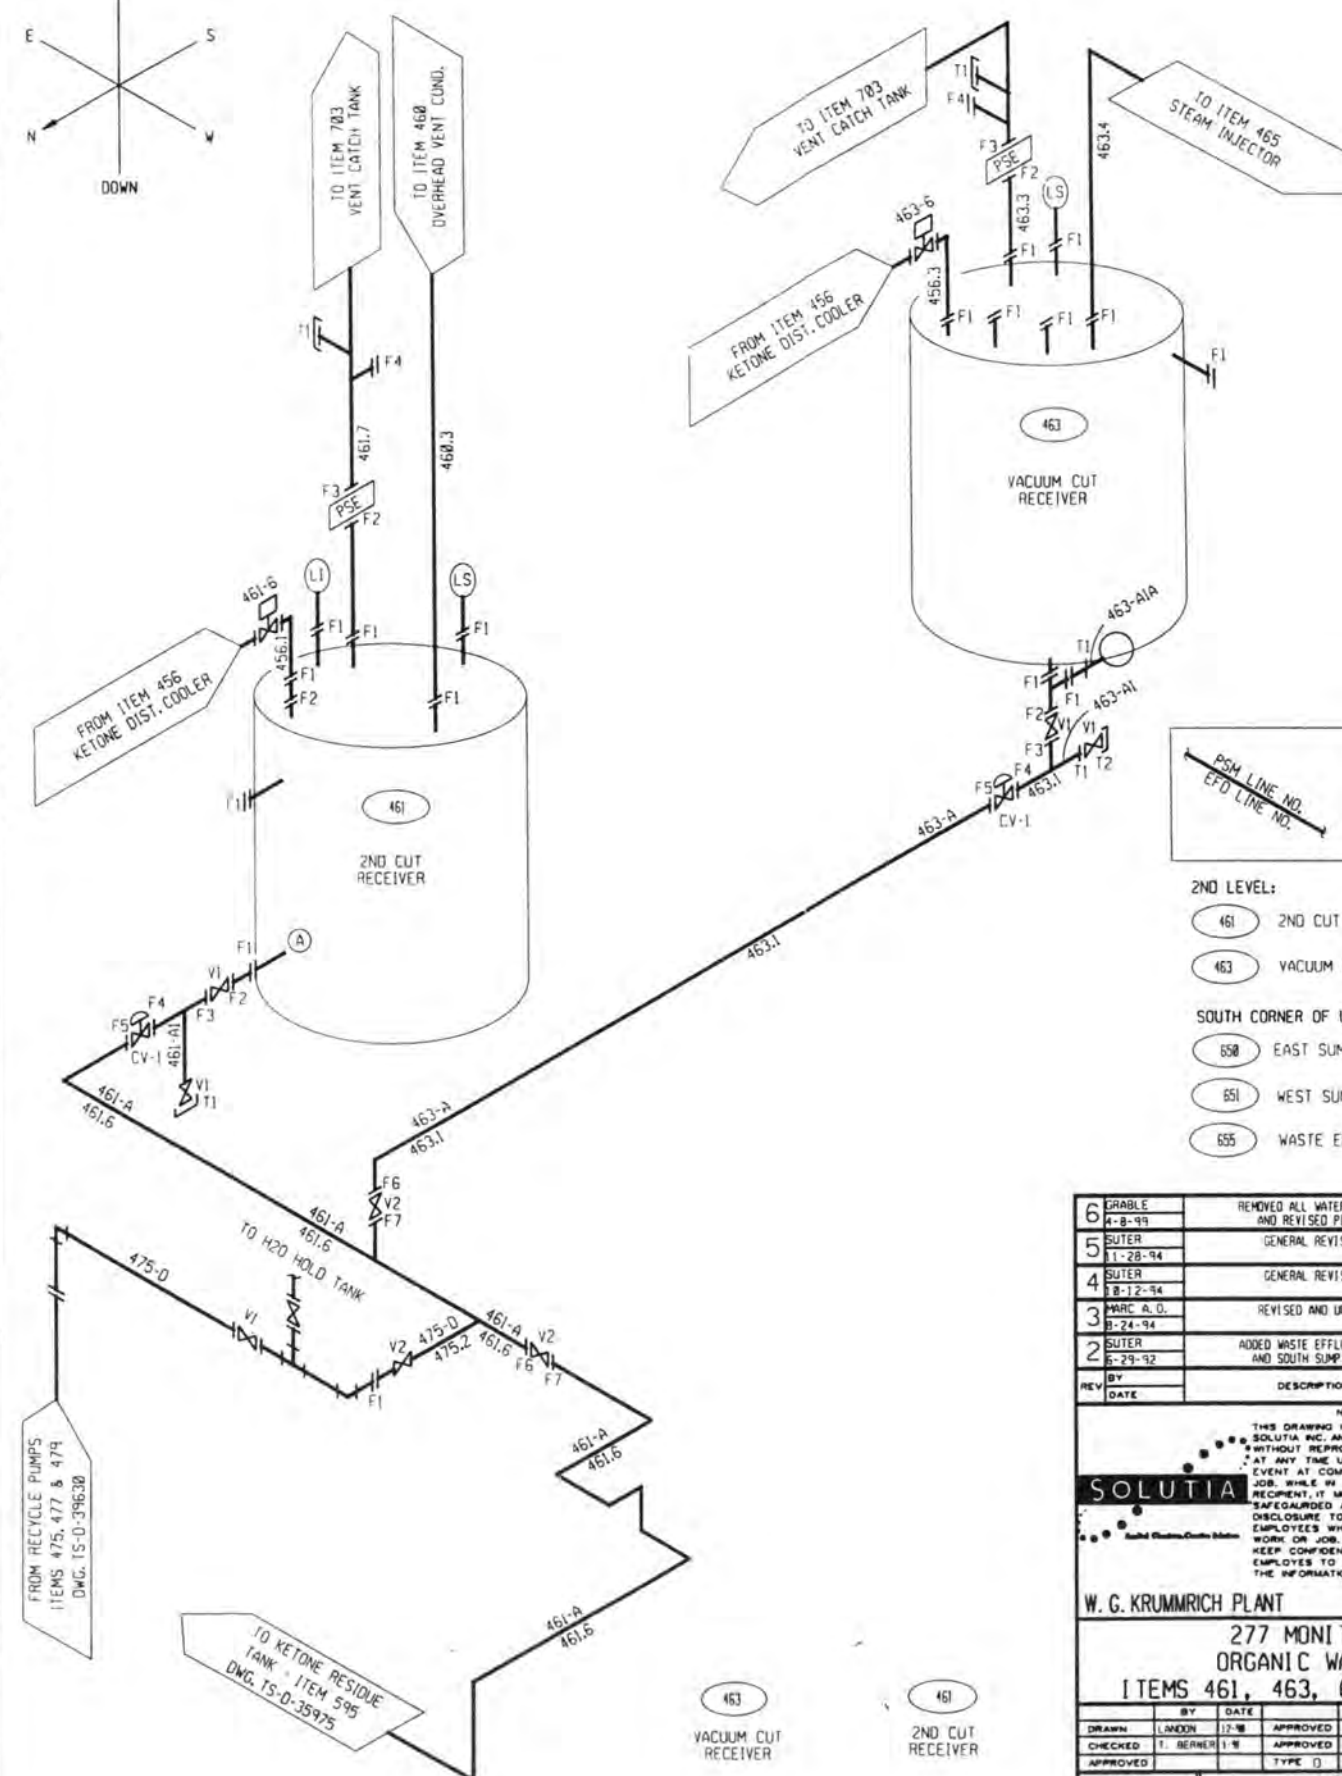
SCALE NONE DWS NO. TS-D-35969 REV. 6

2ND LEVEL:
461 2ND CUT RECEIVER
463 VACUUM CUT RECEIVER
SOUTH CORNER OF UNIT:
650 EAST SUMP PUMP
651 WEST SUMP PUMP
655 WASTE EFFLUENT SUMP

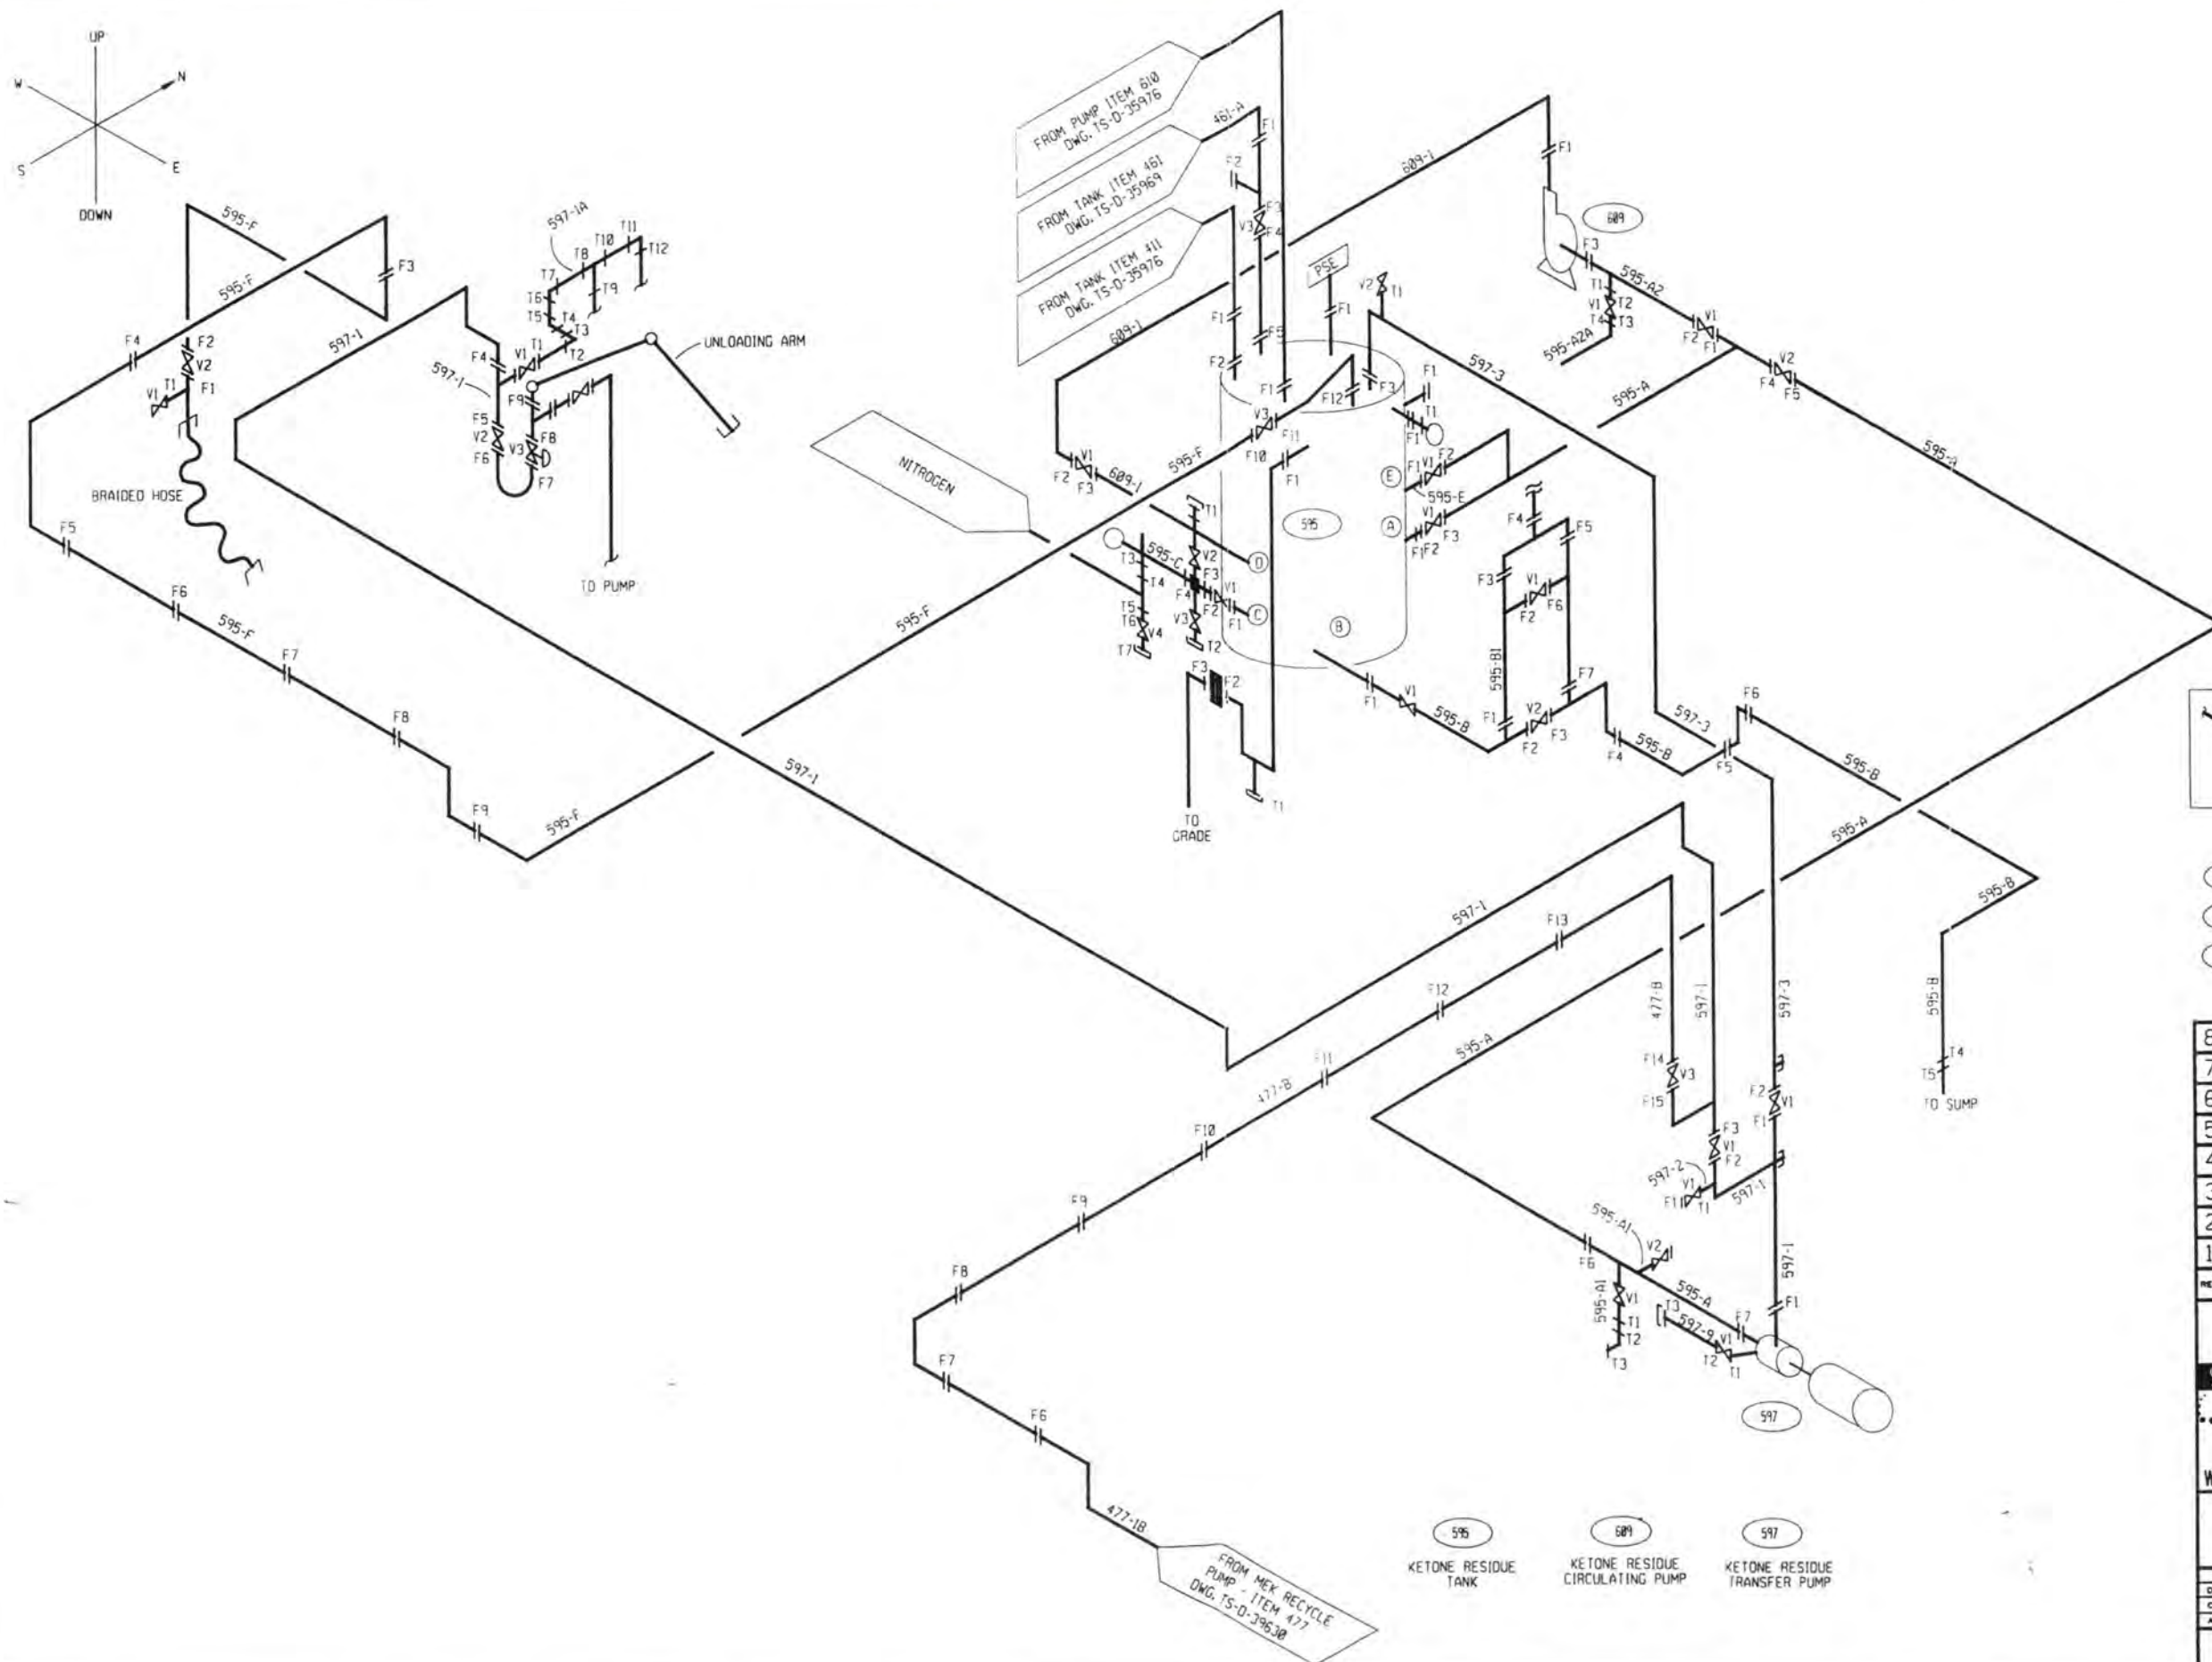
SCALE	DWG. NO.	REV
NONE	TS-D-35975	8

- 595 KETONE RESIDUE TANK
- 597 KETONE RESIDUE TRANSFER PUMP
- 689 KETONE RESIDUE CIRCULATING PUMP

277 MONITOR
KETONE RESIDUE TANK / PUMP
ITEM 595 / 597

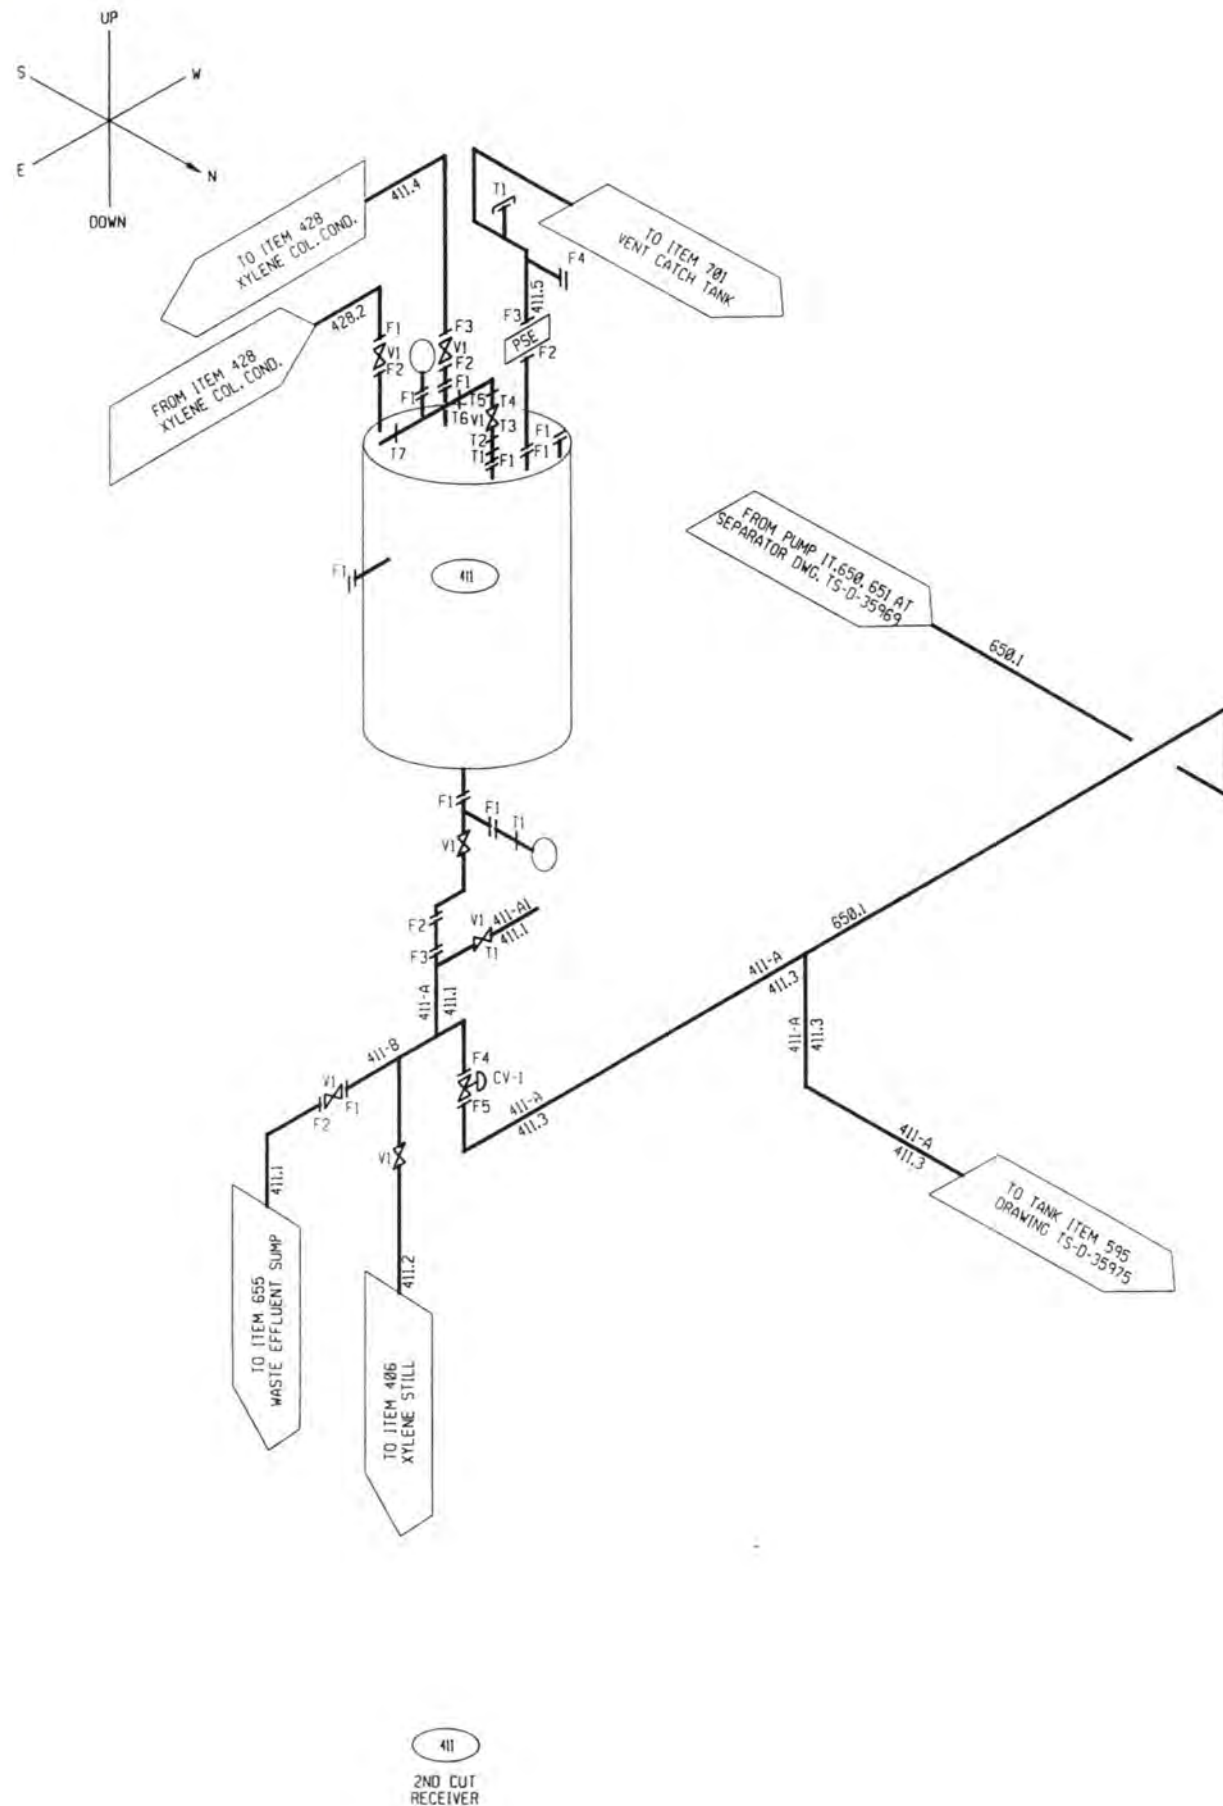
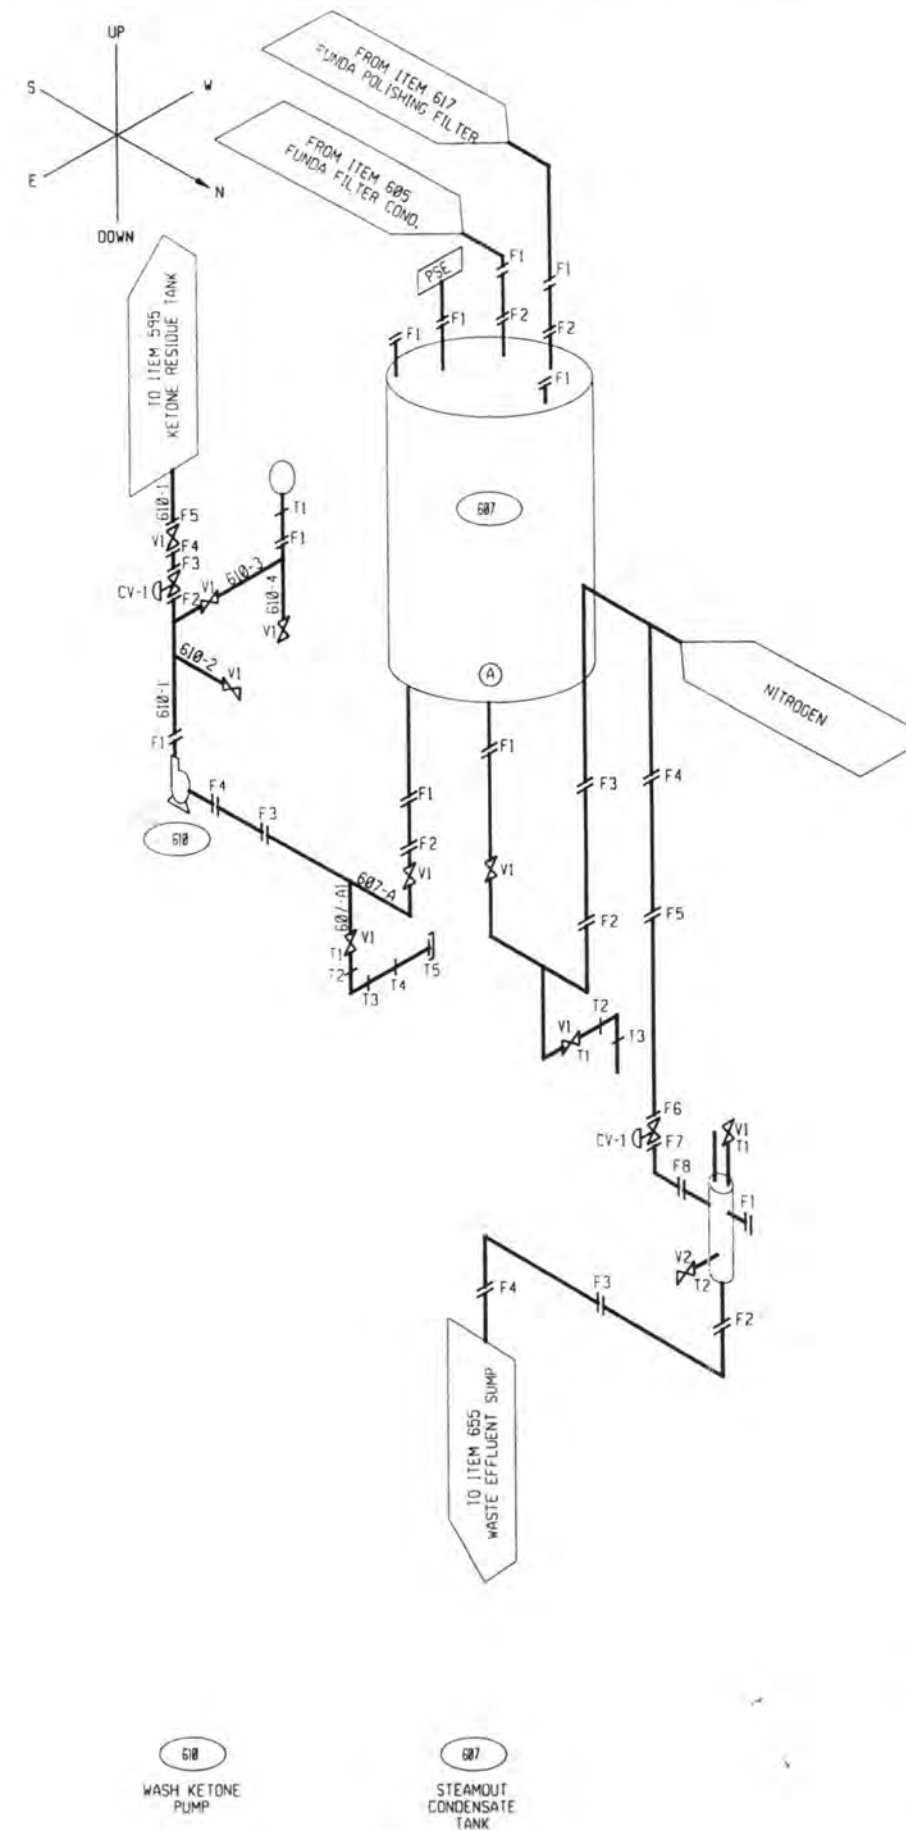
- 411 2ND CUT RECEIVER
- 607 STEAMOUT CONDENSATE TANK
- 608 WASH KETONE PUMP

W. G. KRUMMRICH PLANT			SAUGET, IL		
277 MONITOR ORGANIC WASTE TANKS ITEM 411 / 607					
DRAWN	BY	DATE	APPROVED	BY	DATE
CHECKED	T. BERNER	1-18	APPROVED		
APPROVED			TYPE D	EST. NO.	
SCALE	NONE		DWG. NO.		REV
			TS-D-35976		4

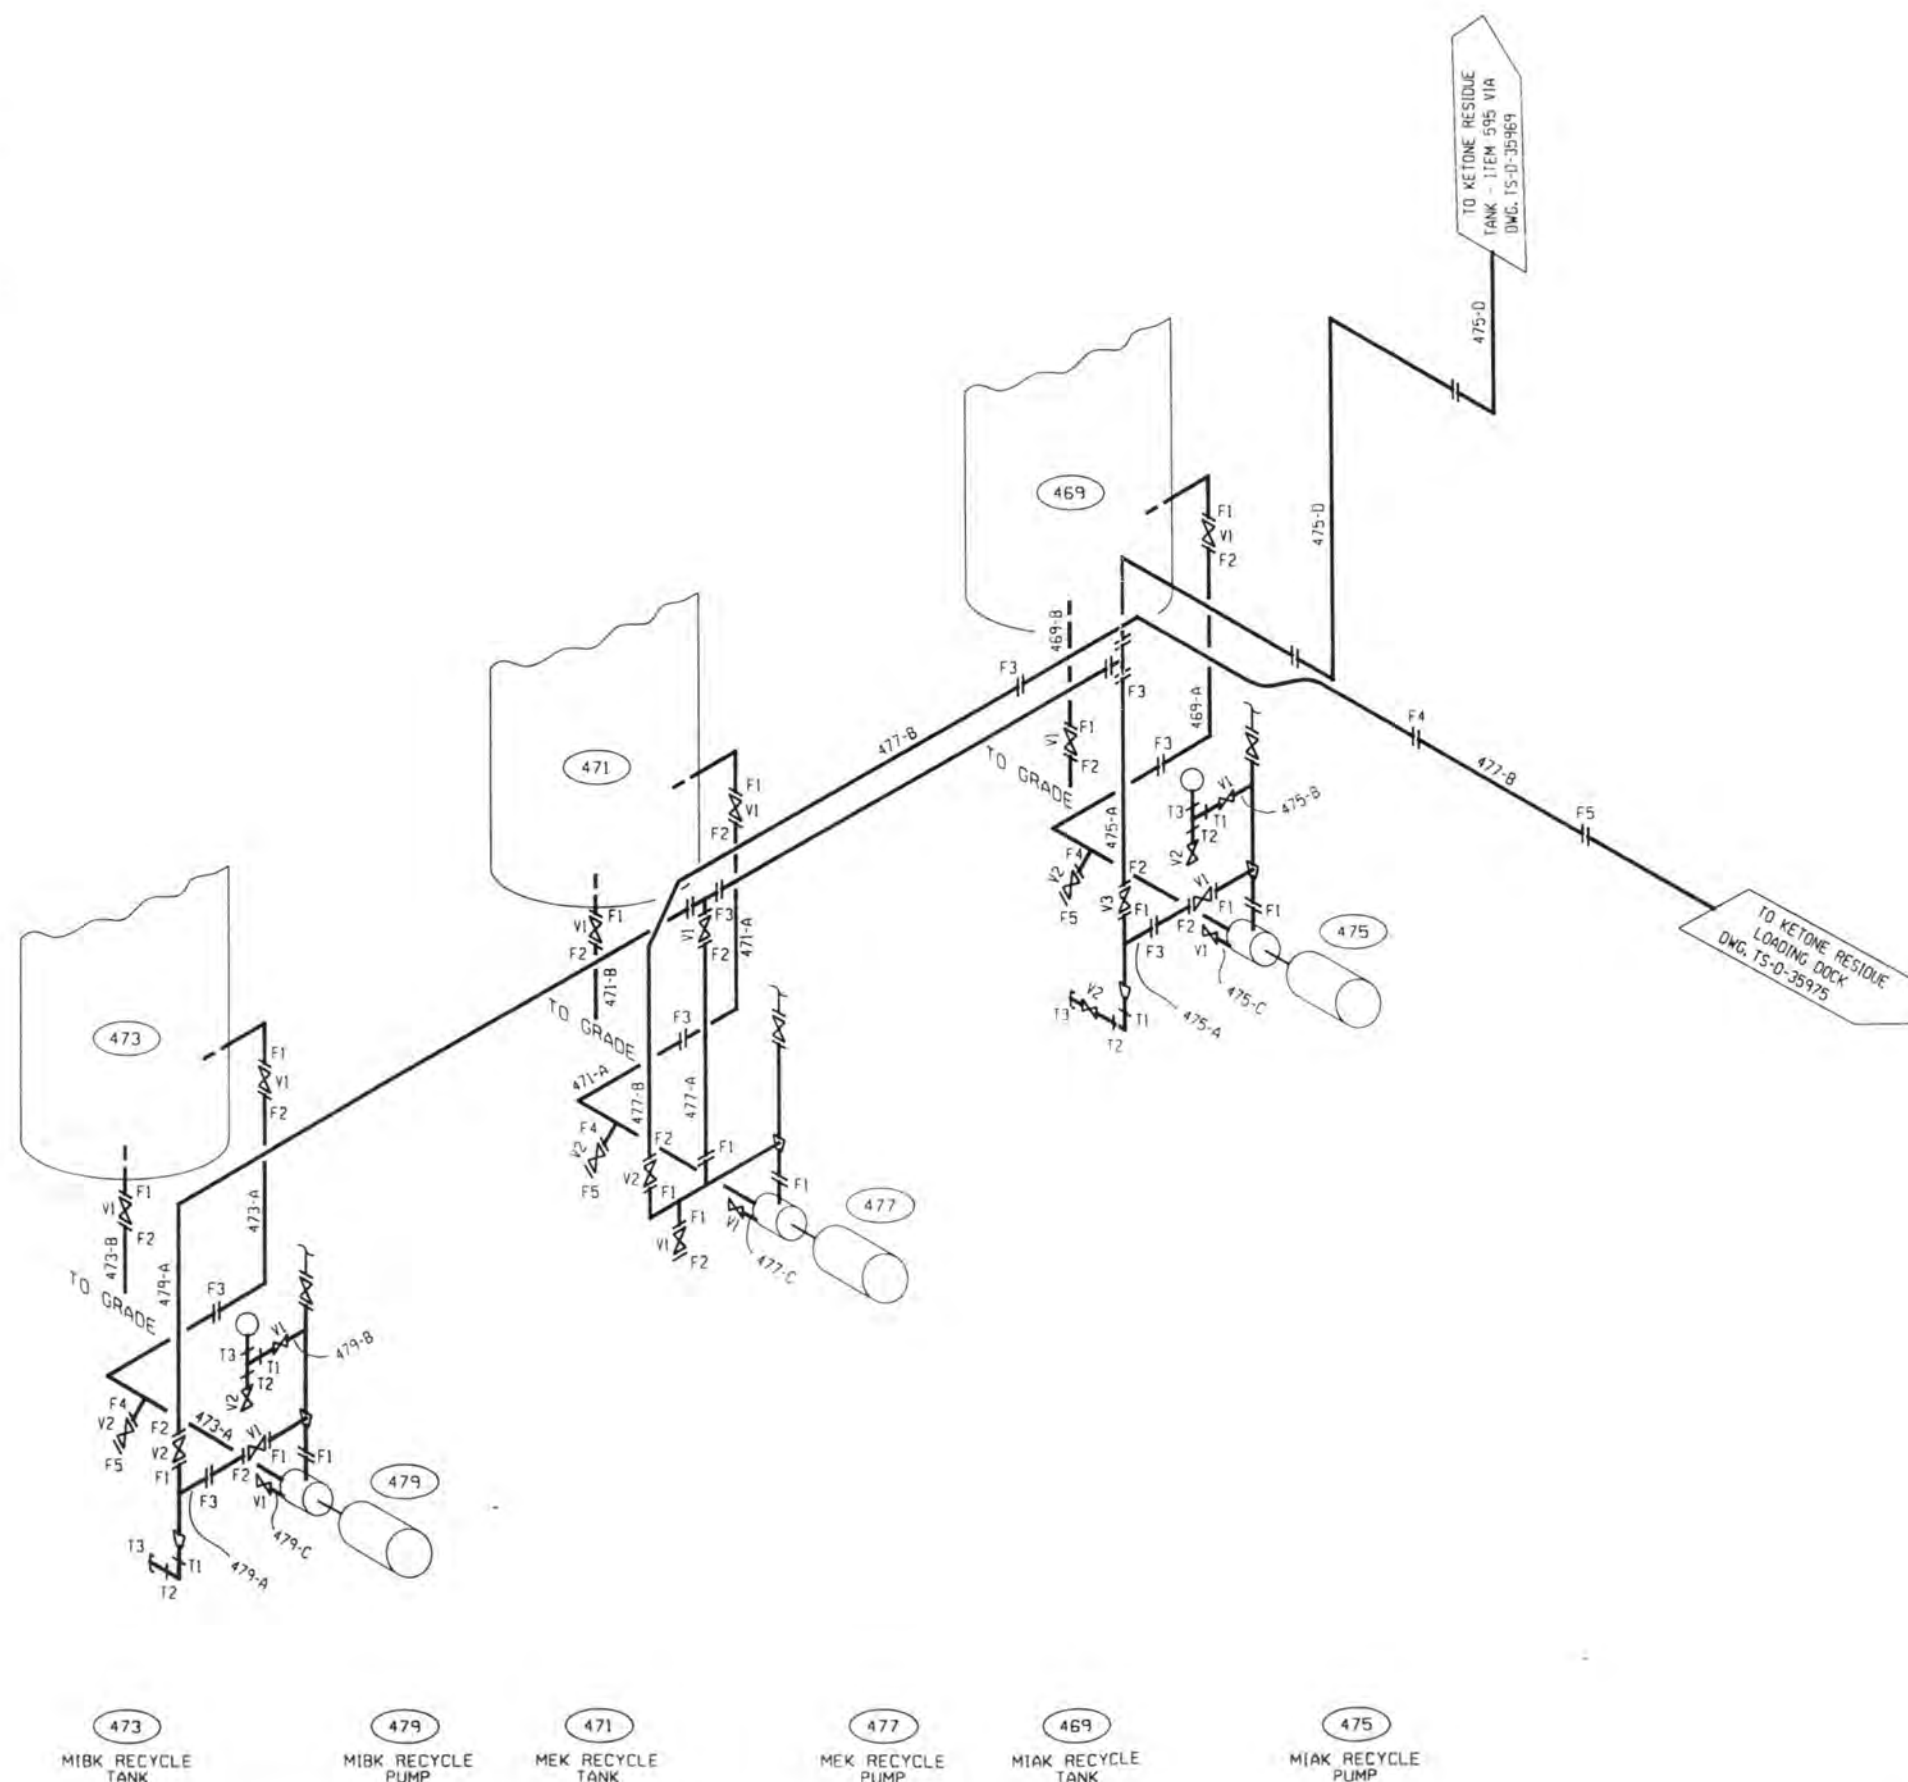
- 469 MI AK RECYCLE TANK
- 471 MEK RECYCLE TANK
- 473 MIBK RECYCLE TANK
- 475 MI AK RECYCLE PUMP
- 477 MEK RECYCLE PUMP
- 479 MIBK RECYCLE PUMP

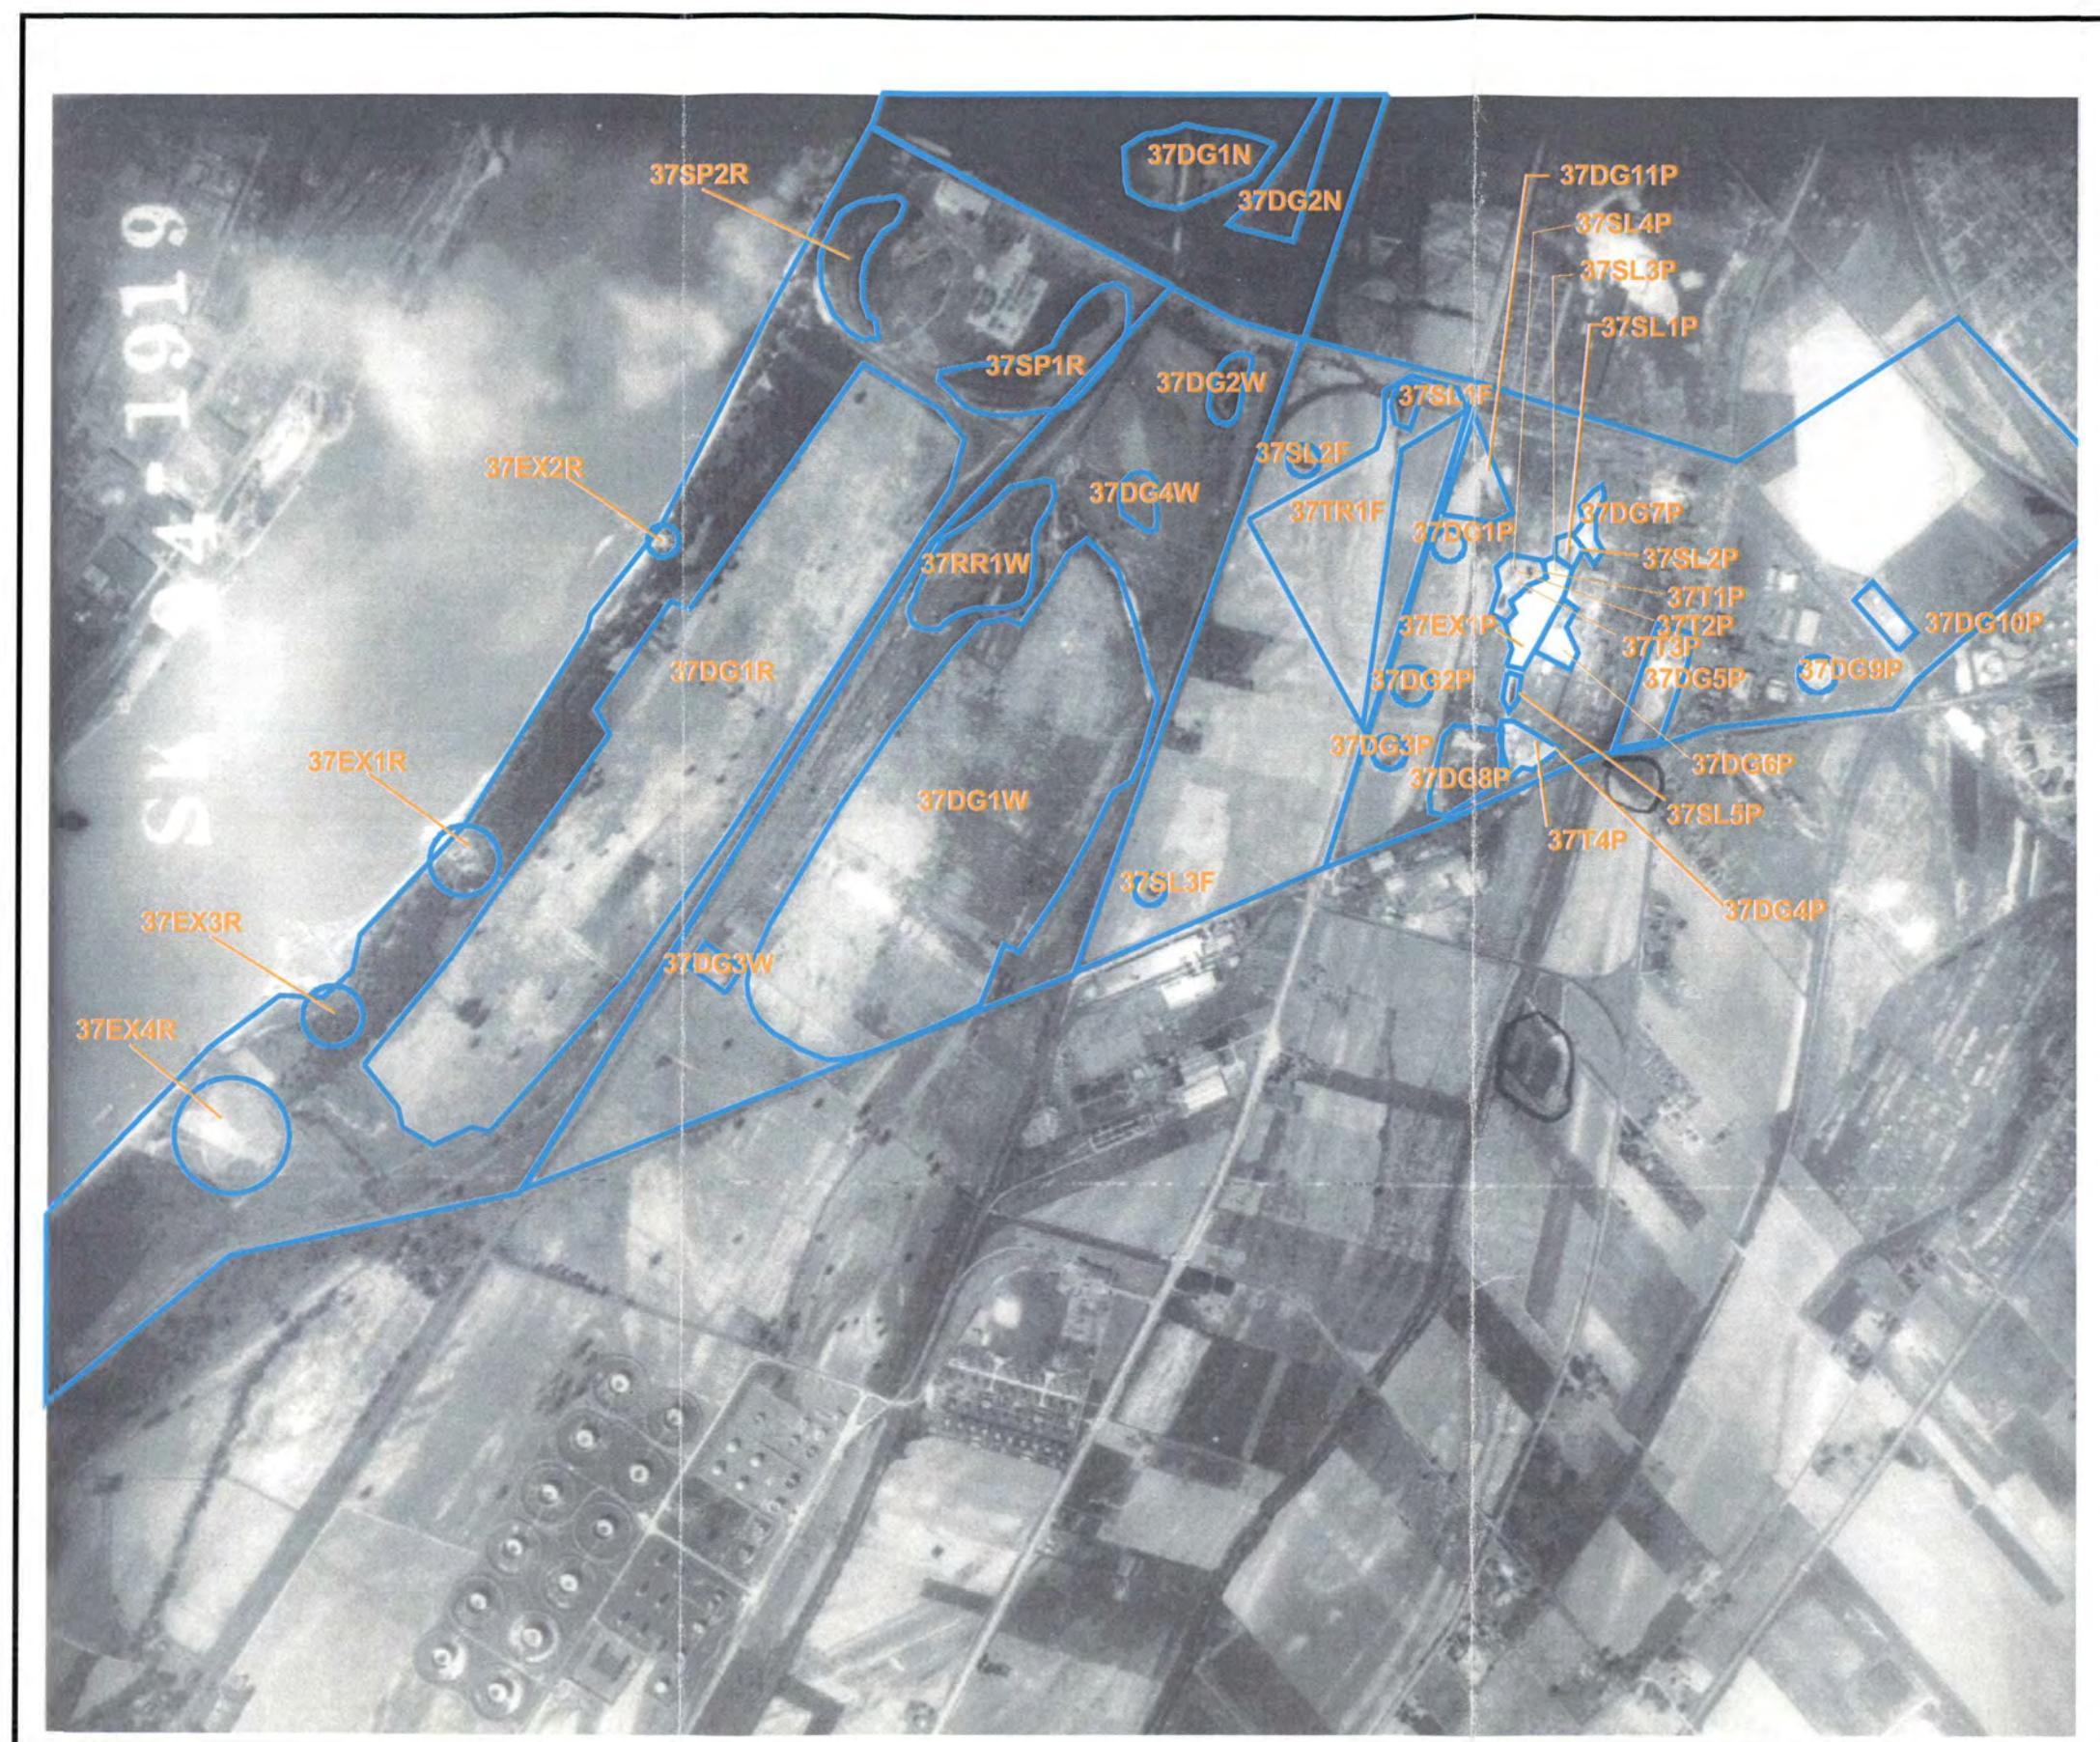
1

3.2 INTERPRETATION OF 1940 PHOTOGRAPH

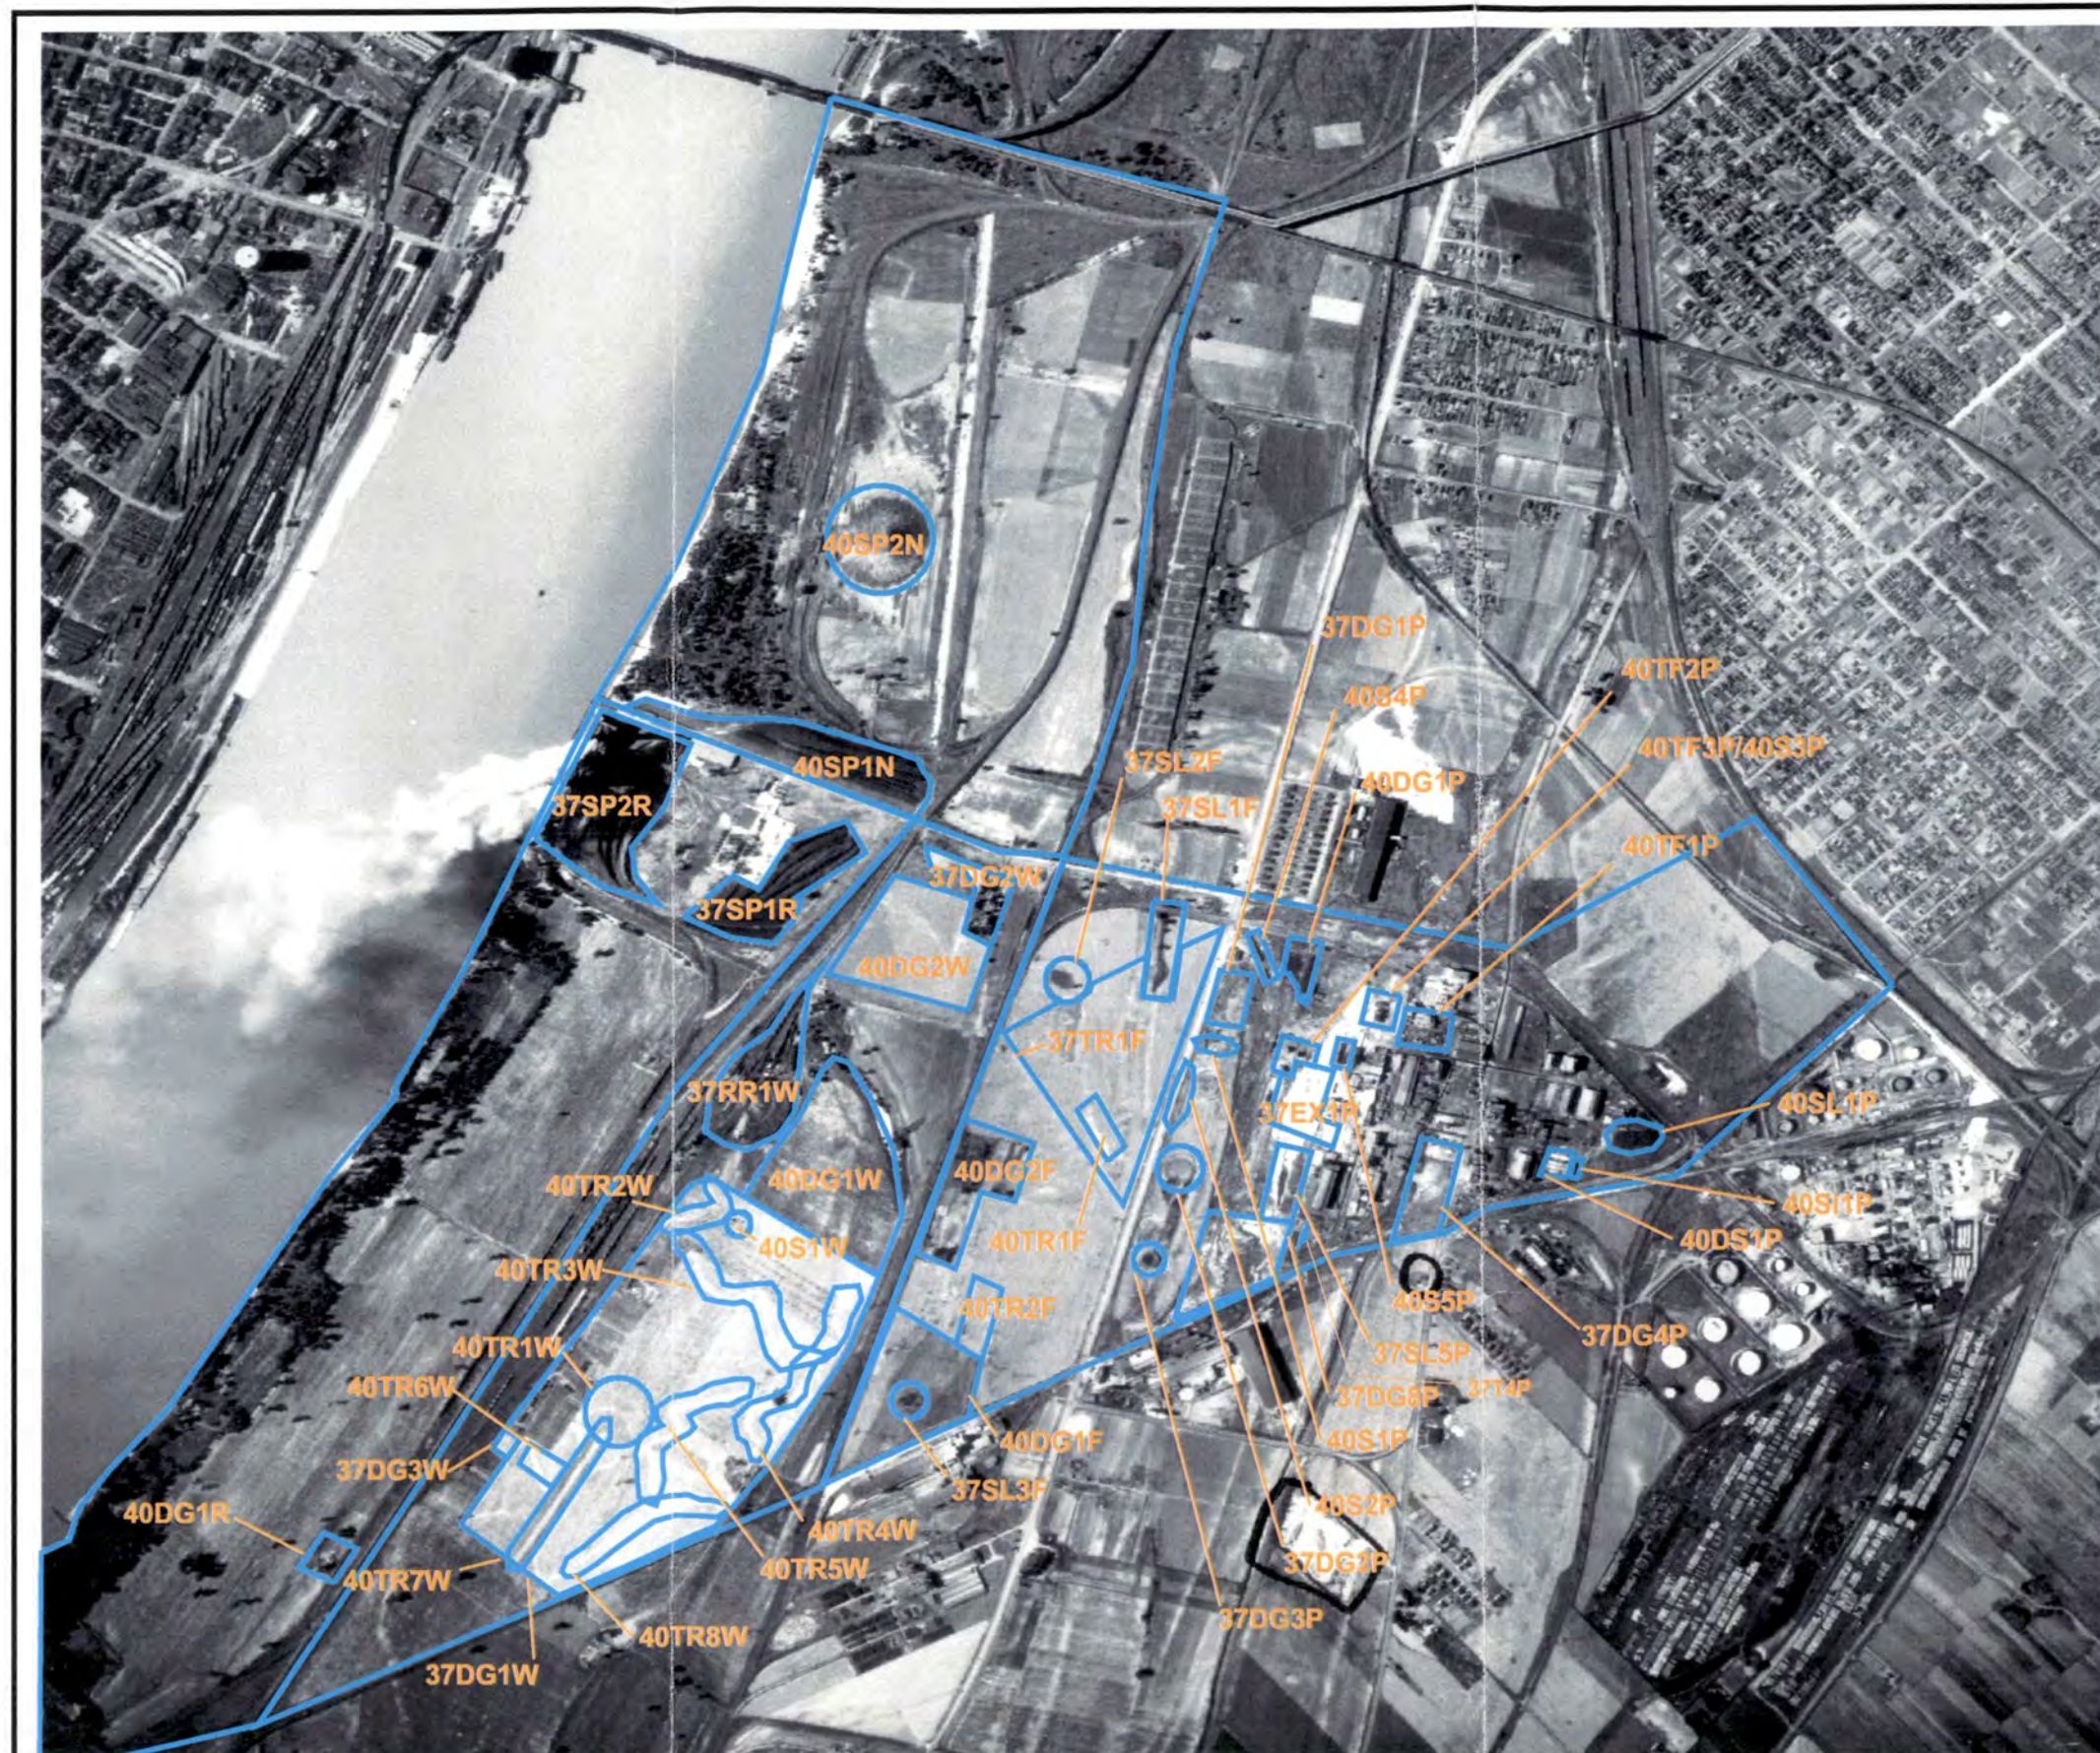
2

3.3 INTERPRETATION OF 1950 PHOTOGRAPH
